OPTIMUS AUTO TRADING GROUP

Vehicle Inspection Report

Stock No.: OAT-R1R7AN

Stock No.	OAT-R1R7AN	**Chassis Number**	WDF44760323040901
Engine Size	1598 cc	**Transmission**	MANUAL
Mileage	220,400 km	**Registration Date**	2016-03-28
Make and Model	Mercedes-Benz VITO 109 CDI MT LONG	**Exterior Colour**	WHITE
Propellant	DIESEL	**Seats**	3
Dimensions	5.25 × 1.91 m

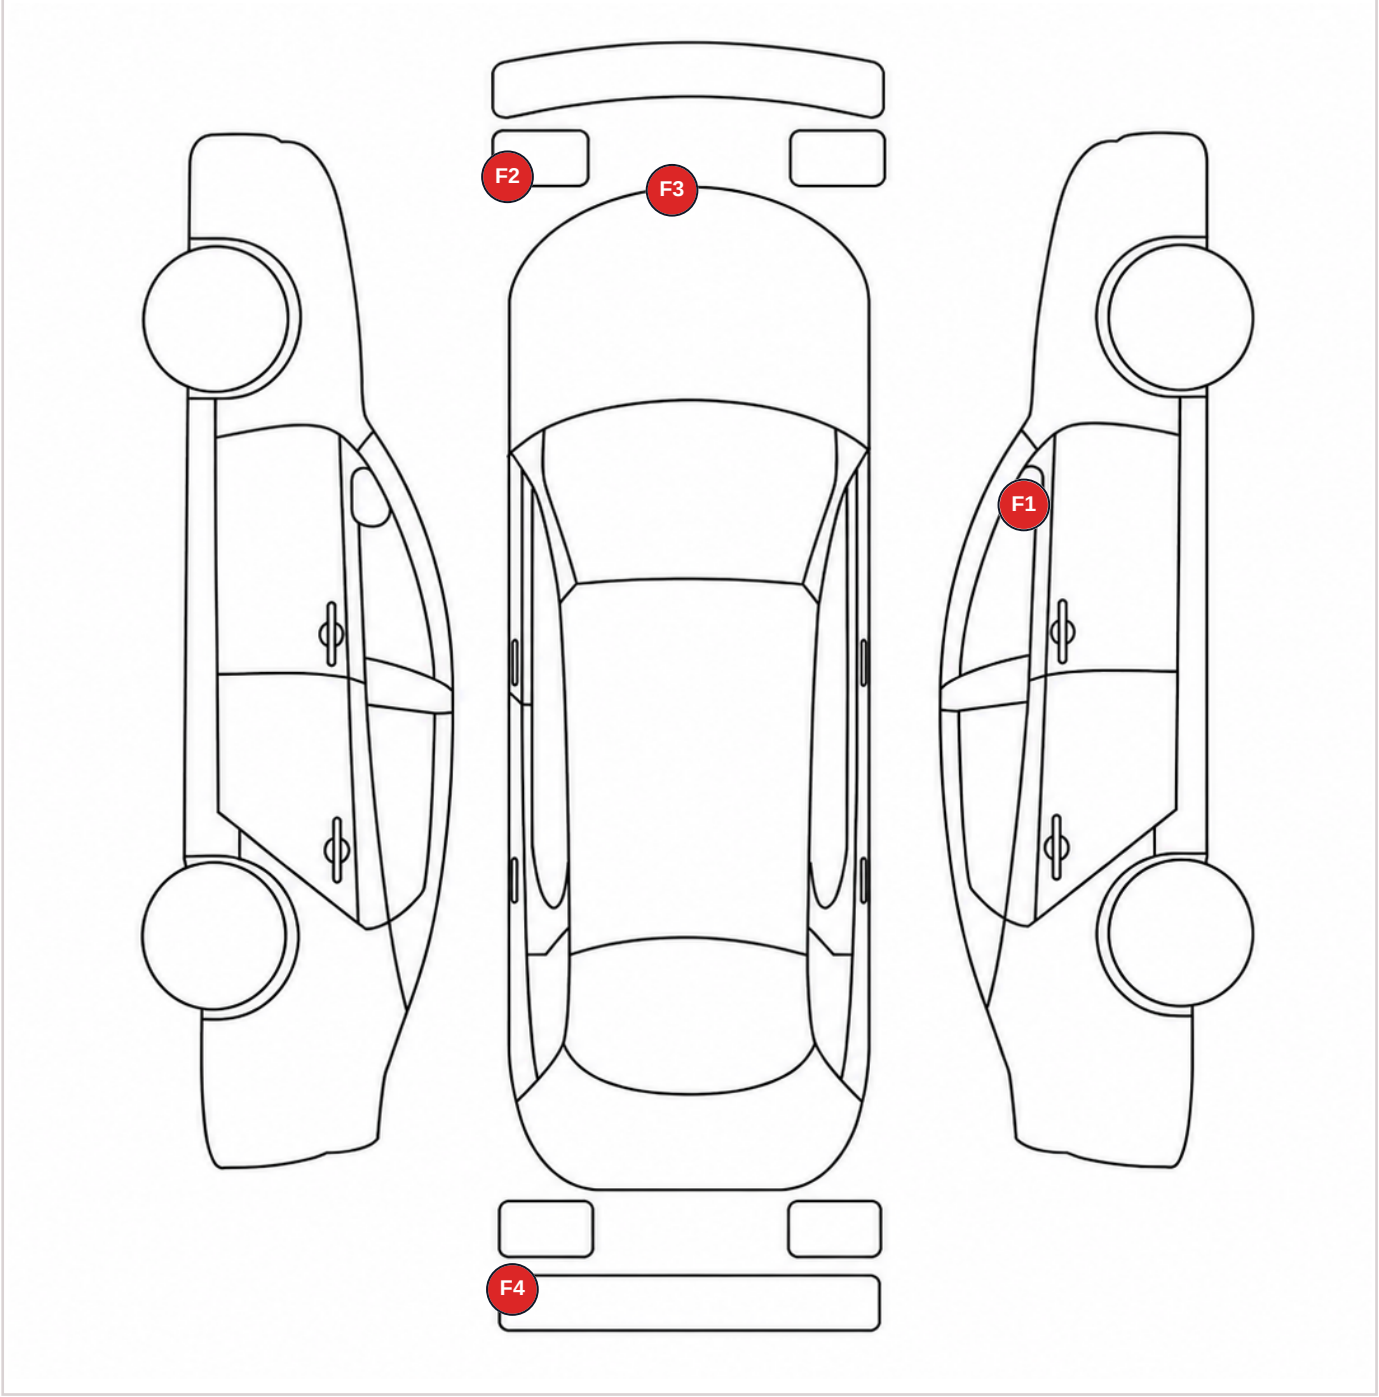
No.	Defect	Information Details
F1	Other	Minor scratch (Rigt side mirror)
F2	Other	Minor scratch (Left side headlamp)
F3	Other	Minor scratch (Front hood)

No.	Defect	Information Details
F4	Other	Loose bumper (Rear left bumper)
